| City of Baltimore Wet<br>Smoke and Dyed | Page 1 of 1 | |
| Sewershed: Gwynns Falls | Date: 9/9/2009 | |
| Manhole_ID: S02CC1007MH | Test ID: <u>D1032-027009</u> | Notification Made: NA (Residents, Fire, 311) |

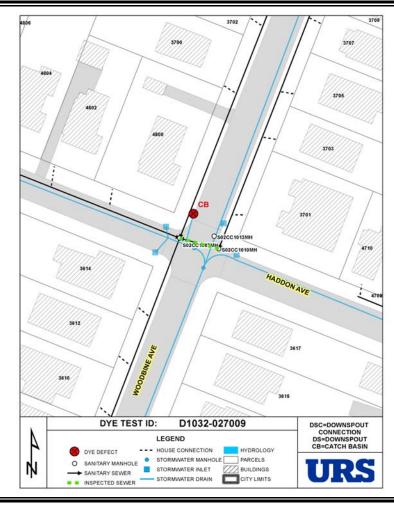
Field Sketch: Show all manholes with Numbers, Blower Placement Locations, Sandbag or Isolation Locations, Street Names, Building Addresses and Locations, Defect Locations and Photo Numbers.

| Defect Loc | Obs_ClockFrom | Obs_ClockTo | Observation | Obs_Remarks |
|---|---|---|---|---|
| 4 | | | Dye Test Visible | DYE SEEN AT JOINT |
| 7 | | | Dye Test Visible | DYE SEEN AT JOINT |
| 10.89999962 | | | Dye Test Visible | DYE SEEN AT JOINT |
| 14 | | | Dye Test Visible | DYE SEEN AT JOINT |
